Bijlage 1

Tabel 2 uit het WMP 2018 (EP201810244166): Overzicht van surveillance activiteiten en testen die uitgevoerd worden tijdens water injectie

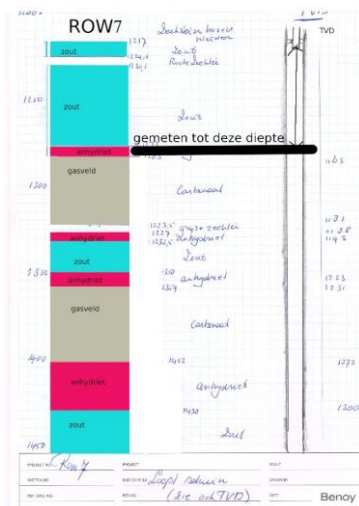
Figuur 1

The maximum wall penetration depth measured in each well since start of injection is presented as degree of pitting in Figure 6-2. The red dashed line indicates the pitting degree limit of 60%, at which NAM's practice is to consider change-out of the tubing, References [12] and [13]. WellCat modelling shows that with 60% corrosion (i.e. assuming worst case scenario that 60% pitting exists uniformly along the entire tubing) the axial and tri-axial loads are approaching the design factors. Figure 6-2 shows that the measured degree of pitting, based on the maximum recorded pitting depth (considered the weakest point in the tubing) for all wells is still below the pitting degree limit of 60%, except for ROW-7. The 2016 survey indicated pitting just above 60%. However, repeat surveys in 2017 and 2018 showed significantly lower maximum wall thickness loss, indicating that the observed pit in 2016 is relatively small in size (given that the 24 arms of the caliper tool did not detect the same pit both in 2017 and 2018). The 2020 survey again indicated the pitting at the same depth to be about 60%. The overall integrity of the ROW-7 tubing condition is still classified as moderate, but the tubing section with the deepest pitting will be considered for pro-active repair.
